Project:	GIF #167 – Bellevue Country Club
Project Owner:	Private
Project Location:	Bellevue Country Club
Sewershed:	Harbor Brook
CSO:	078/018
GI Technology:	Porous Pavement, Added Green Space, Inflow Control
Capture Area:	418,249 sq. ft.
Runoff Reduction:	7,375,800 gal/yr
Year Contracted:	2020
GIF Award:	\$177,540

FACT SHEET

Bellevue Country Club

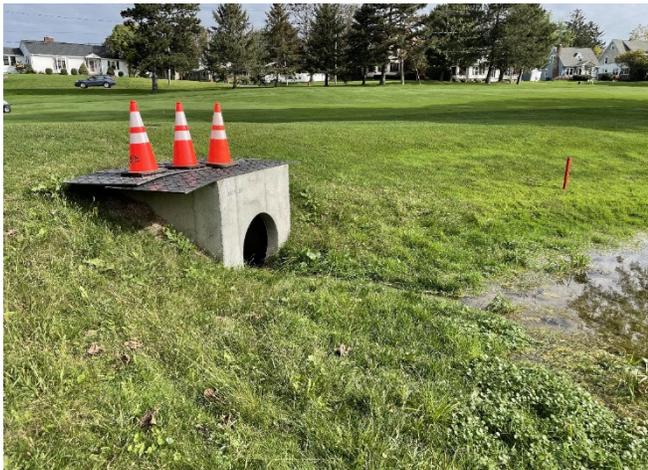
Post-Construction photo of the new overflow structure for the lower pond

Prior to the project, the ponds on the golf course were a significant source of inflow into the combined sewer system during wet periods. By controlling that flow with the new overflow structure, the storage within the ponds is maximized and flows to the combined sewer are reduced. The control of the outlet flow from the lower pond provides a significant benefit to the combined sewer system; over 6 million gallons of flow will be detained annually as a result of the change.

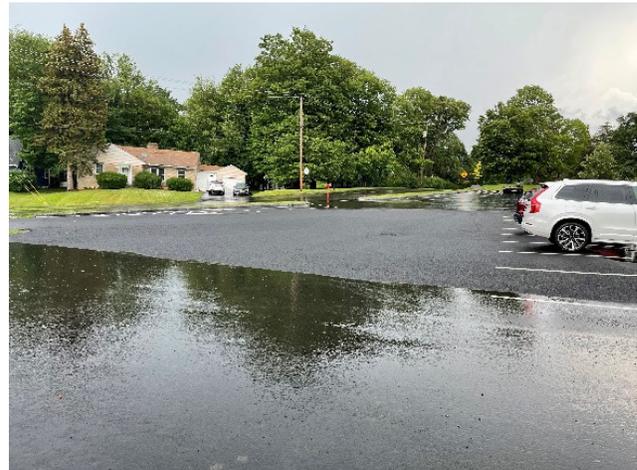
Post-Construction photo showing porous pavement section of parking lot

A portion of the parking lot and driveway areas at the club were replaced with porous asphalt pavement. The total area of porous pavement is 5,175 square feet and allows for a minimum of one inch of rainfall to be captured and infiltrated into a subsurface infiltration trench. The total area draining to the porous asphalt is approximately 35,840 square feet, which will result in an annual runoff capture of 640,800 gallons of stormwater. Added greenspace was added along the northeast side of the parking lot to further reduce stormwater runoff and improve traffic flow into and out of the parking lot.
